**HYUNDAI**  
**Technical Service Bulletin**

GROUP <b>RECALL</b>	NUMBER <b>26-01-042H</b>
DATE <b>MAY 2026</b>	MODEL(S) <b>SEE BELOW</b>

**SUBJECT:** FRONT SEAT BELT ANCHOR RETAINER CLIP INSTALLATION  
 (RECALL 298)

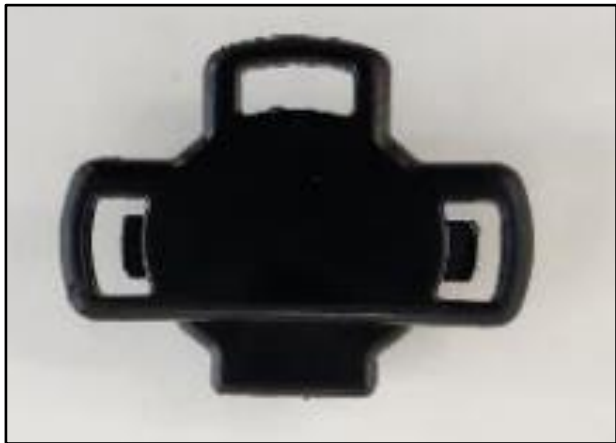
**Description:** For certain Santa Fe (MX5A), Santa Fe Hybrid (MX5A HEV), and IONIQ 6 (CE EV) vehicles, the front seat belt may not be properly secured to the seat frame due to a damaged snap-on anchor(s), which could increase the risk of injury to occupants in the event of a crash. This bulletin provides instructions to install reinforcement clips on the snap-on lower seat belt anchor(s) and if necessary, replace the seat belt.

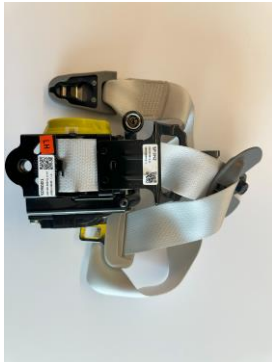
Model	Part Name	Part Number	Figure	Remarks
Santa Fe (MX5A)	Stopper (Clip) – S/Belt	88815-XX000QQH

QTY: 2 per vehicle (clips sold in packs of 10)
Santa Fe Hybrid (MX5A HEV)	S/Belt Assy – FR LH	88810-XXXXX

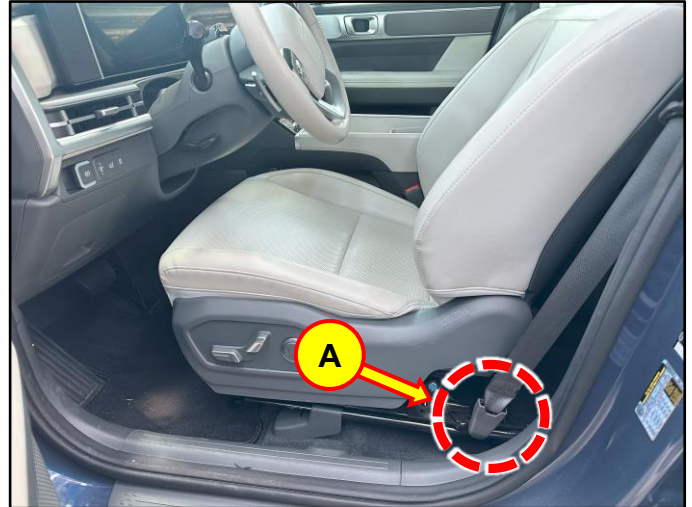
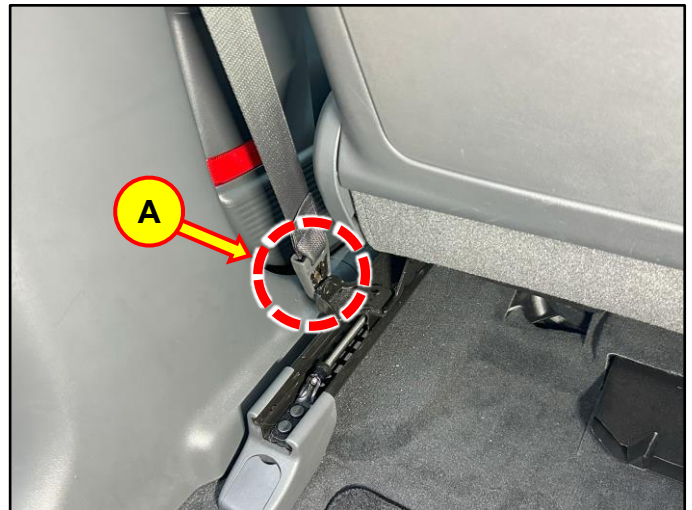
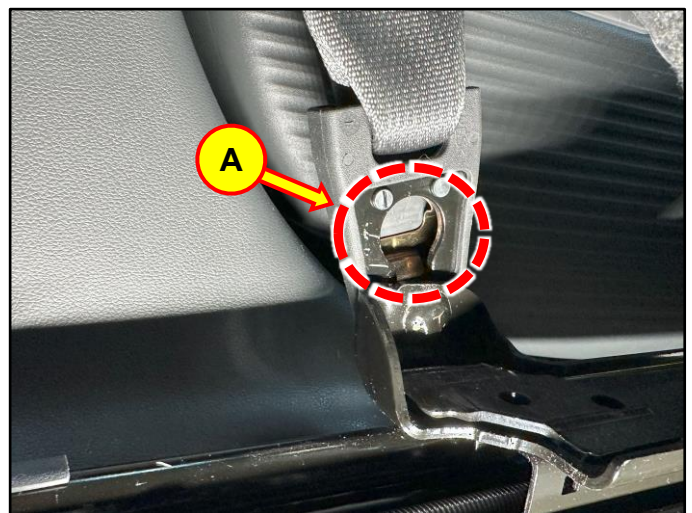
1. Move the front seat to the most forward and upward position to locate the snap-on lower seat belt anchor (A).

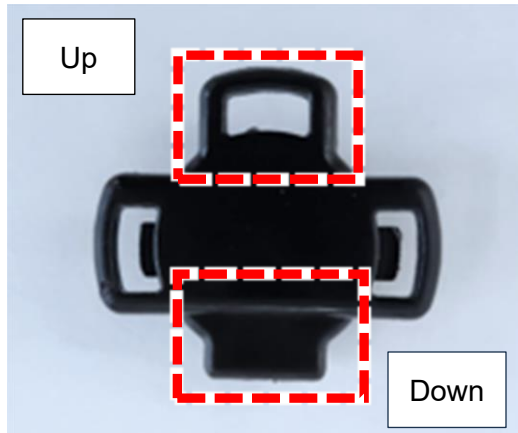
2. Install the retainer clip (B) by inserting it into the circular anchor opening and firmly pressing until fully seated.

The retainer clip has a vertical direction, so ensure that it is mounted accordingly.

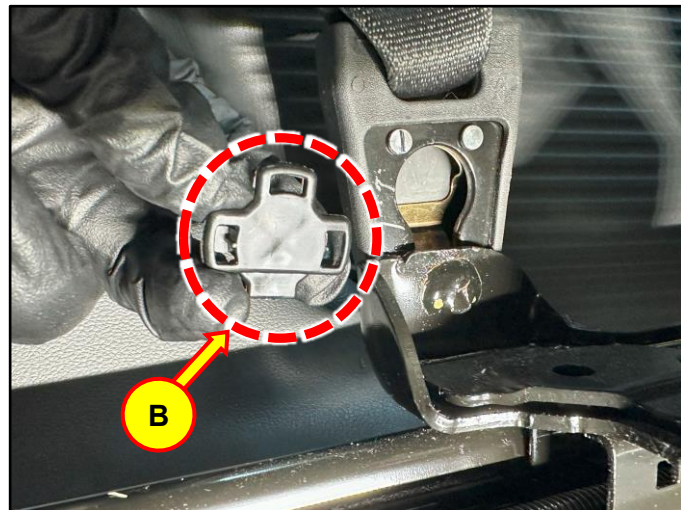
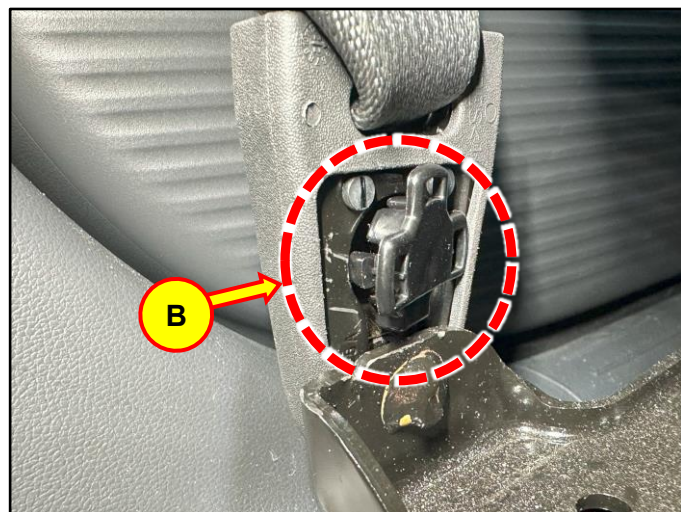
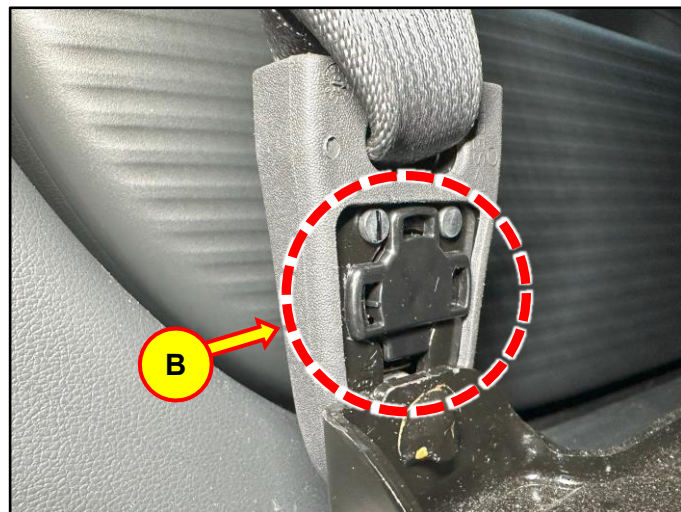
Ensure that the retainer clip's tab does not roll outward from the bracket hole during mounting.

Even if the metal tab from inside the seat belt anchor is broken or bent, proceed with the retainer clip installation.

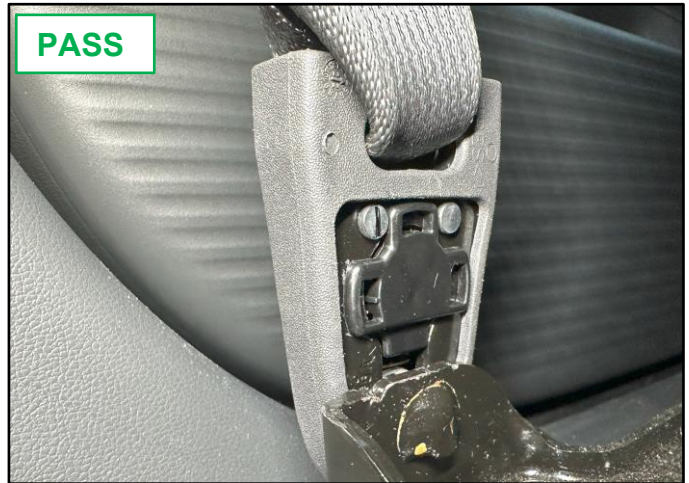
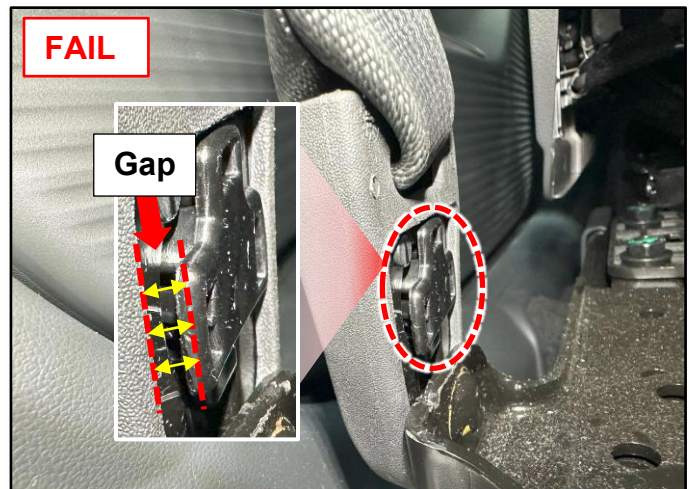
3. Push the retainer clip into the snap ring anchor until it is completely seated against the anchor surface.

If a gap is present, reinsert the retainer clip and push again until it is fully seated.

- **PASS:** If the retainer clip is fully seated, proceed to **step 4**.
- **FAIL:** If the retainer clip **CANNOT** be seated flush after reinserting, proceed to the [Front Seat Belt Replacement](#) section.

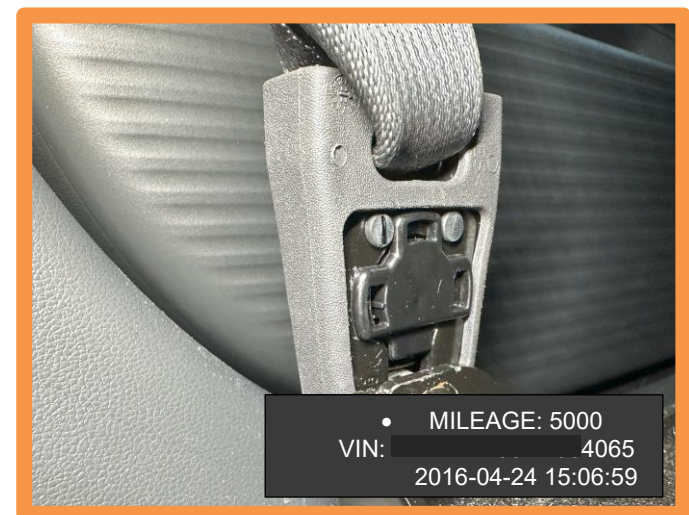
Using the STUI camera function, take a photo of the installed retainer clip.

**NOTE:** If the STUI camera function is **NOT** used, write the last 6 digits of the VIN and date of repair on a piece of paper to include in the photo.

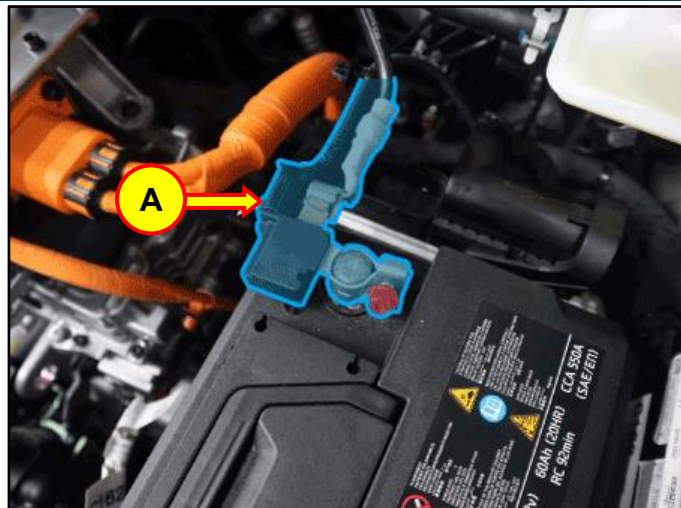
1. Disconnect the **12V** negative (-) battery terminal (A):

Model	Remove Part	Location
MX5A & CE EV	Negative (-) Terminal	Engine bay
MX5A HEV		Tailgate area underneath luggage mat

lb-ft	7.2
lb-in	86
N.m	8.8

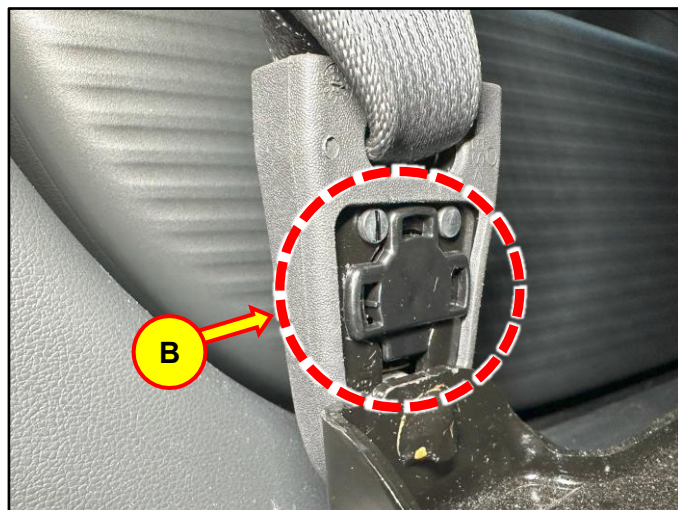
2. Remove the front seat belt by referring to the shop manual:
  - **Body (Interior / Exterior / Electrical) > Seat Belt > Front Seat Belt Pretensioner > Removal**
3. Install the new front seat belt in the reverse order of the removal process, then reconnect the **12V** negative (-) battery terminal.
4. Install the retainer clip (B).

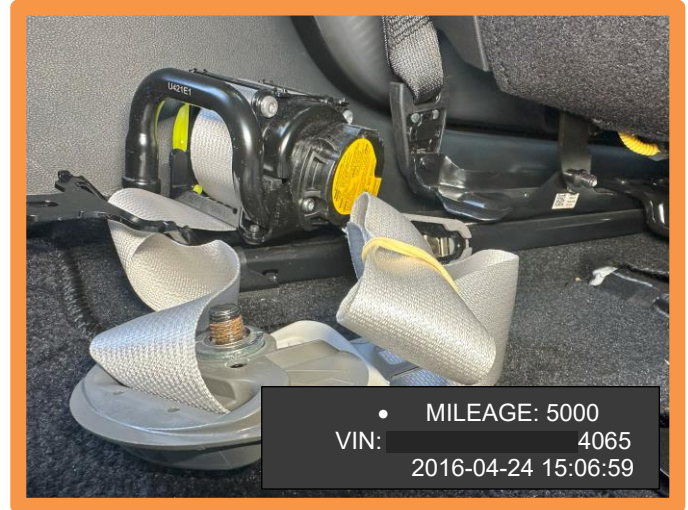
Using the STUI camera function, take a photo of the faulty seat belt next to the new seat belt with the retainer clip installed.

**NOTE:** If the STUI camera function is **NOT** used, write the last 6 digits of the VIN and date of repair on a piece of paper to include in the photo.
