# HYUNDAI Technical Service Bulletin

Group	TRANSAXLE
Number	03-40-010
Date	JUNE, 2003
Model	2001-02 ACCENT 1.6L ATA

Subject  
**SHOCK OR DELAYED ENGAGEMENT DURING  
 PARK TO REVERSE OR PARK TO DRIVE SHIFT  
 TCM REPROGRAMMING INSTRUCTIONS**

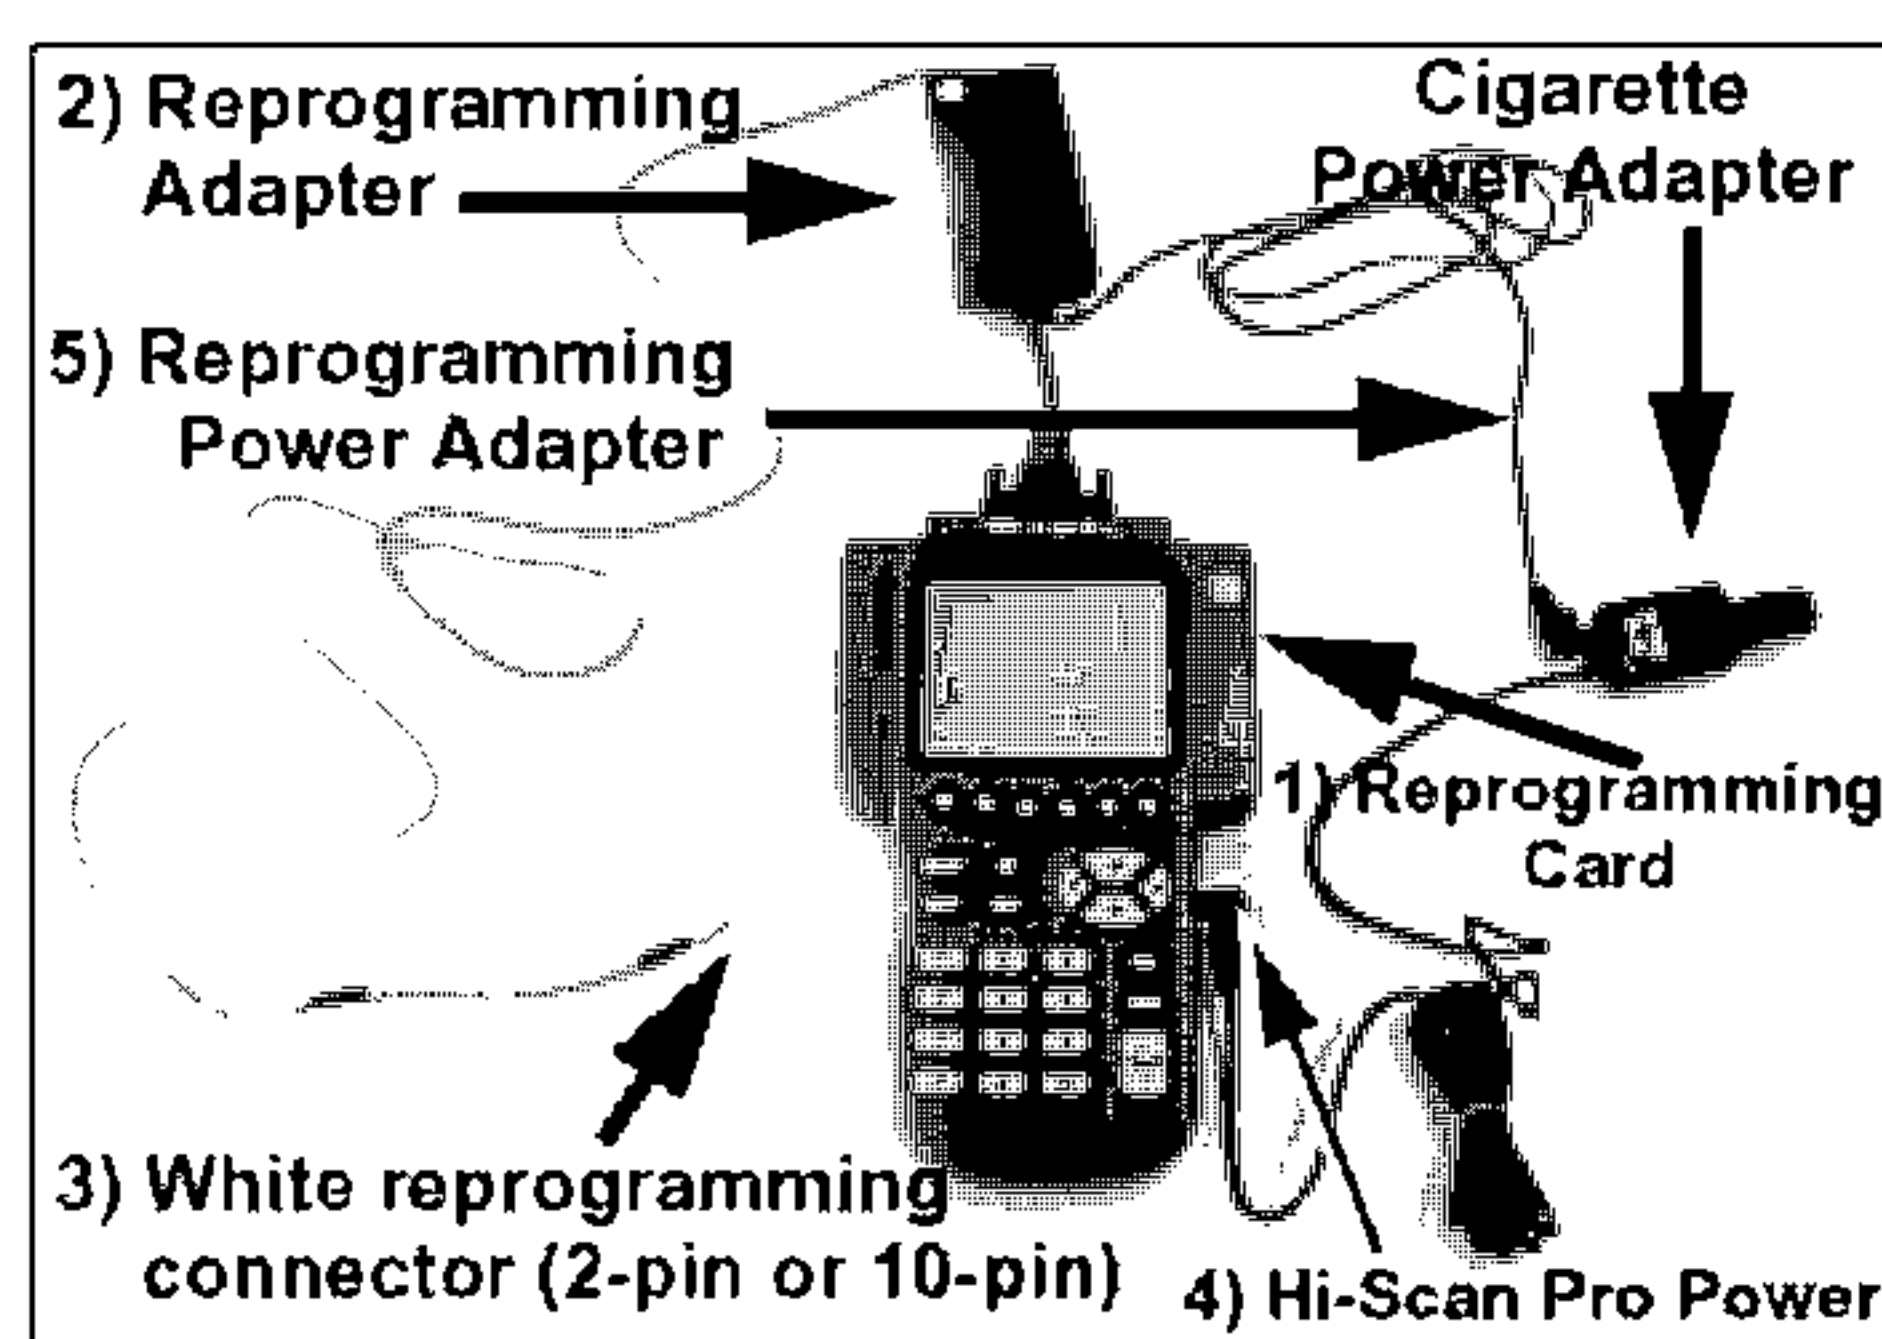
1. Remove any software cards from the Hi-Scan Pro and insert reprogramming card into the Hi-Scan Pro top slot.
2. Connect the reprogramming adapter to the Hi-Scan Pro.
3. Connect the white reprogramming connector (2-pin or 10-pin) to the reprogramming adapter.

**NOTE: Use the correct reprogramming connector.**

- 2001 Accent produced prior to 3/30/01: White 2-pin reprogramming connector.
- 2001 Accent produced from 3/30/01 and 2002 Accent: White 10-pin reprogramming connector.
